ROADWAY SPAN STABILITY IN THICK SEAM MINING - FIELD MONITORING AND NUMERICAL INVESTIGATION AT MORANBAH NORTH MINE

Baotang Shen¹, Brett Poulsen¹, Michael Kelly¹, Jan Nemcik² & Chris Hanson³

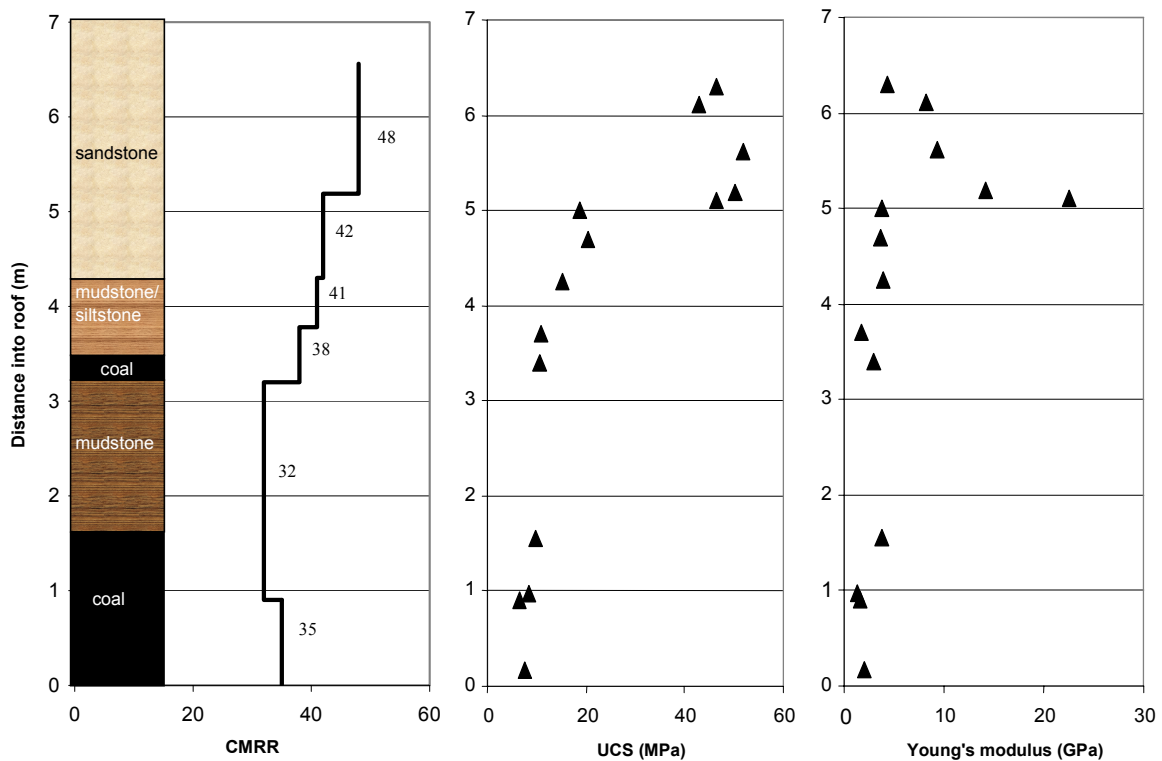
FIG. 1 - Roof geology, CMRR, rock strength and Young's modulus in the monitored holes

The geology from the drill holes is generally consistent. The typical roof geology in the monitored area is shown in Figure 1. The immediate roof is 1.7m coal. It is of C3 type (40-60% bright) immediately above the roof and becomes dull coal with bright bands at the top of the seam. Overlying the coal seam is a weak to very weak mudstone unit. The mudstone unit has a thickness of about 1.8m. Above this unit is the Goonyella Rider Seam (GMR) which has an average thickness of 0.2m. Above the GMR unit is a sequence of mudstone/siltstone/sandstone units.

Also shown in Figure 1 is the Coal Mine Roof Rating (CMRR) for different roof units. The roof coal and the mudstone units have a CMRR value ≤ 35 (Figure 1). According to Mark (1999), unsupported roadway spans with a CMRR less than 46 are considered to be unstable in the long term.

Fourteen coal and rock samples selected from the roof cores were tested in uniaxial compression to determine the strength and deformability (Cunnington and Boland, 2002). The tested Uniaxial Compressive Strength (UCS) and Young's modulus (E) are also plotted in Figure 1.

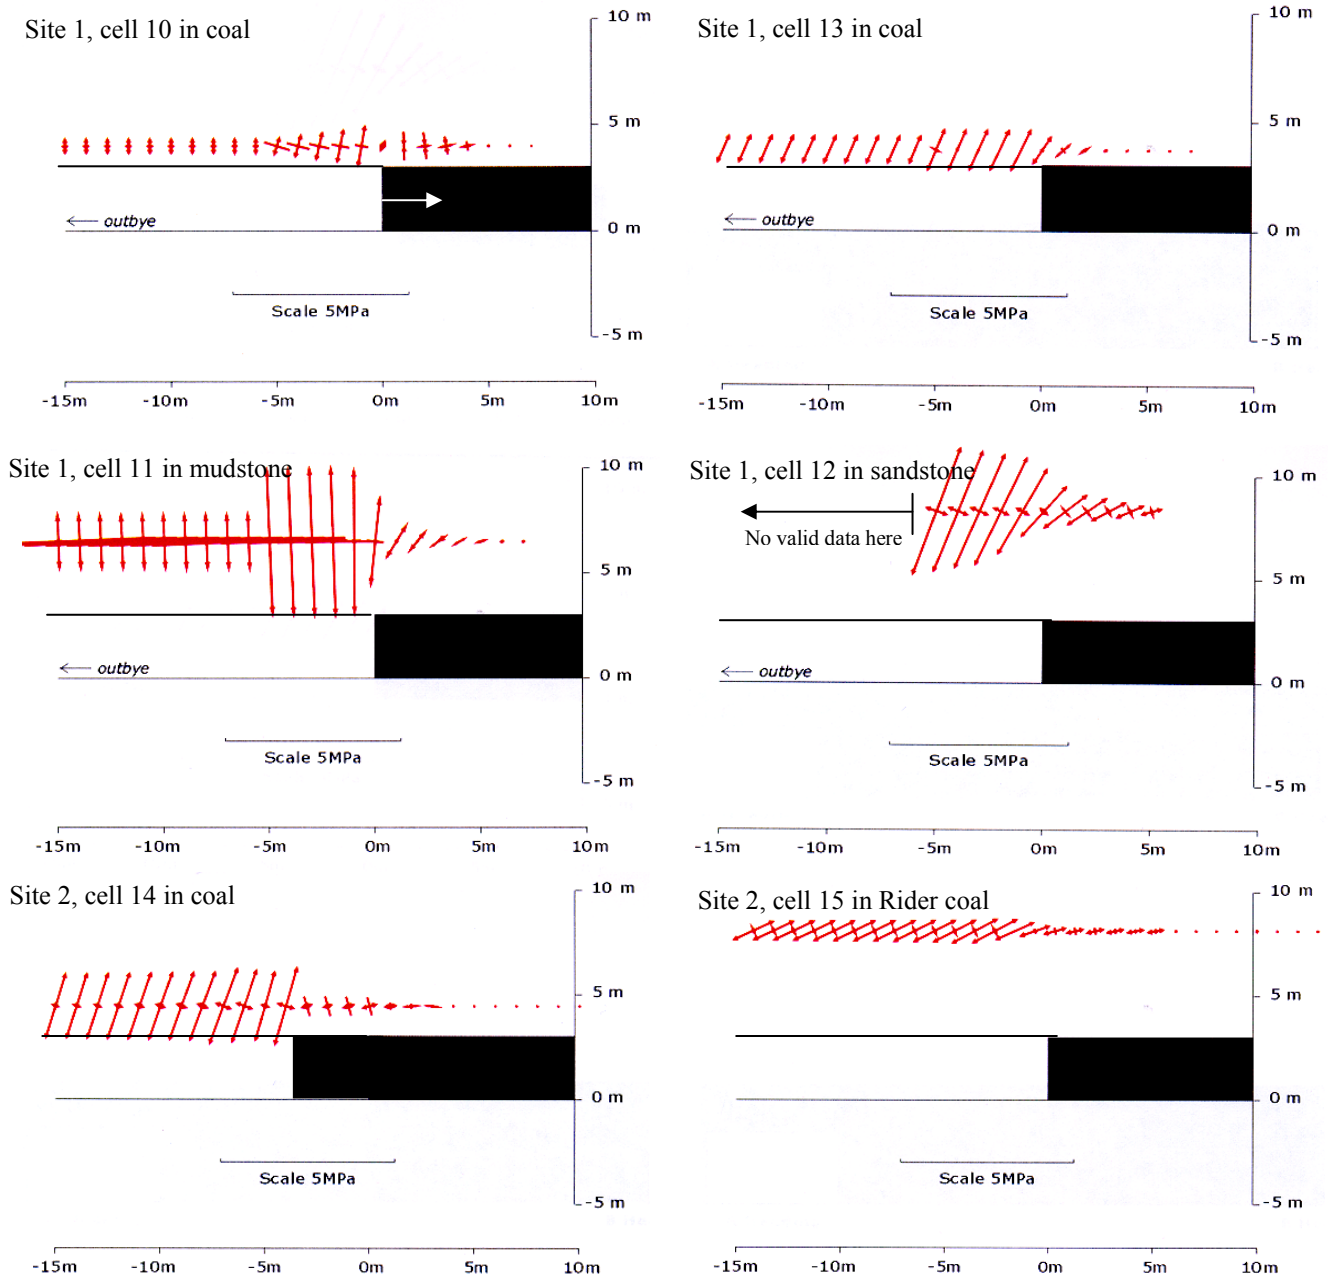
FIG. 5 - Monitored stress change in roof coal and rock units versus roadway face position in a vertical cross section parallel to the roadway axis. Outward arrow indicates reduction of compressive stresses

The measured stress changes in the roof coal, mudstone and sandstone during roadway advance are shown on a vertical section in Figure 5. The vertical stress change in the roof coal with time is shown in Figure 6

Stresses in the roof rotated when the roadway face approached and passed the monitored locations (FIG. 5). At Site 2, cell 15 in the Rider Seam indicated a change in level and orientation implying shearing along the Rider Seam. Vertical stress in the roof dropped sharply immediately after the roadway face passed the monitored locations (Figure 6).

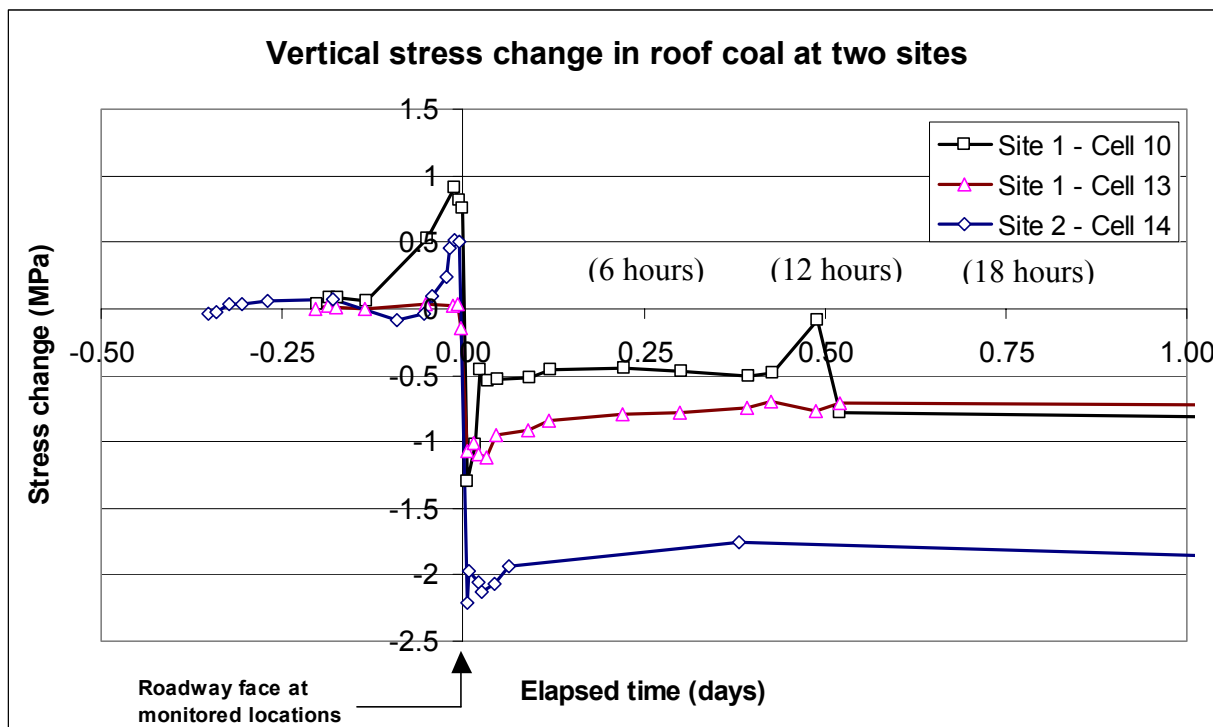
FIG. 6 - Change of vertical stress in the roof coal at the two monitored sites.

After the initial stress drop, the vertical stress recovered partially in the next 2-3 hours in the GM Seam (Figure 6) and the mudstone unit. The recovery continued in the next 12 hours at a reduced rate. No vertical stress recovery was observed in the sandstone roof.

The magnitude of the vertical stress change in the GM Seam at Site 1 was generally consistent with that of *in situ* vertical stress obtained from the overcoring stress measurements. The maximum vertical stress drop is about 1.2-1.3MPa, while the measured *in situ* vertical stress in coal was 1.3MPa. This implies a nearly total release of vertical stress after roadway excavation.

At Site 2, the maximum vertical stress drop in coal roof is about 2MPa, much higher than that at Site 1 and the *in situ* vertical stress measured in the coal pillar between 49 C/T and 50 C/T. The results suggest that Site 2 had a different stress regime from Site 1, and the *in situ* stresses were higher. The difference might be influenced by unknown local geological variations and the existence of geological structures. Two normal faults exist between Site 1 and Site 2. The faults are nearly perpendicular to the roadway axis, both dip in an angle of 70 degrees inbye. One of the faults has no obvious displacement, and the other has a displacement of 0.2m. The fault surfaces are clean and tight. Minor displacement normal faulting of this nature is not uncommon at Moranbah North.

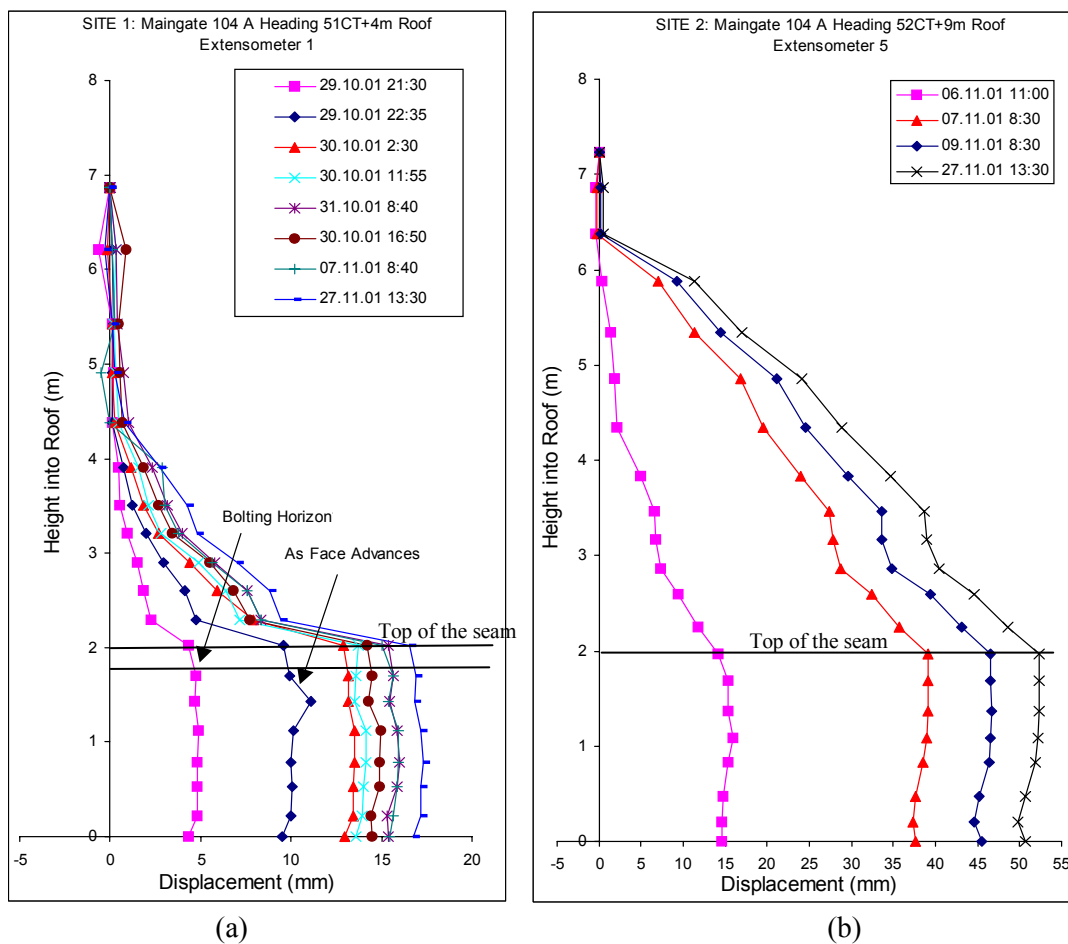
FIG. 7 - Roof displacement at the two monitored sites.

A maximum of 18mm roof movement was recorded at Site 1 (Figure 7a). The recorded displacement is relative to the upper end of the extensometers (7m into roof). The deformation zone extended about 4m into the roof. It is apparent that the bolted roof remained intact as the deformation in the roof coal layer was almost uniform.

The Extensometer 5 at Site 2 recorded a maximum of 50mm roof displacement (Figure 7b), substantially higher than that at Site 1. The deformation zone extended at least 6m into the roof, also higher than that at Site 1.

The larger roof movement at Site 2 is consistent with the higher stress change at this location. The roof displacement data support the suggestion that a different stress regime existed at Site 2 which is separated from Site 1 by two normal faults.
