# CASE STUDY CENTRAL COLLIERY QLD

Dieter Bruggemann<sup>1</sup>

**ABSTRACT:** A coal mine outburst occurred on the 20<sup>th</sup> of July 2001, in 'B' heading of 310 panel. It is the first such incident to have occurred at the mine in its 17 year history. Mining has since the initial days progressed to deeper levels where now the workings are at some 425m below the surface. The issue of greater gas contents with depth is recognised where in-seam cross block drainage hole patterns are employed to drain and therefore reduce gas levels in the developing panels and in the longwall. The outburst incident was intimately related with a geological structure, which was covered by in-seam drainage boreholes. Subsequent to the outburst further training of the workforce and a full review of the coal mine outburst management plan was undertaken. Enormous experience was gained by all involved in the investigation process.

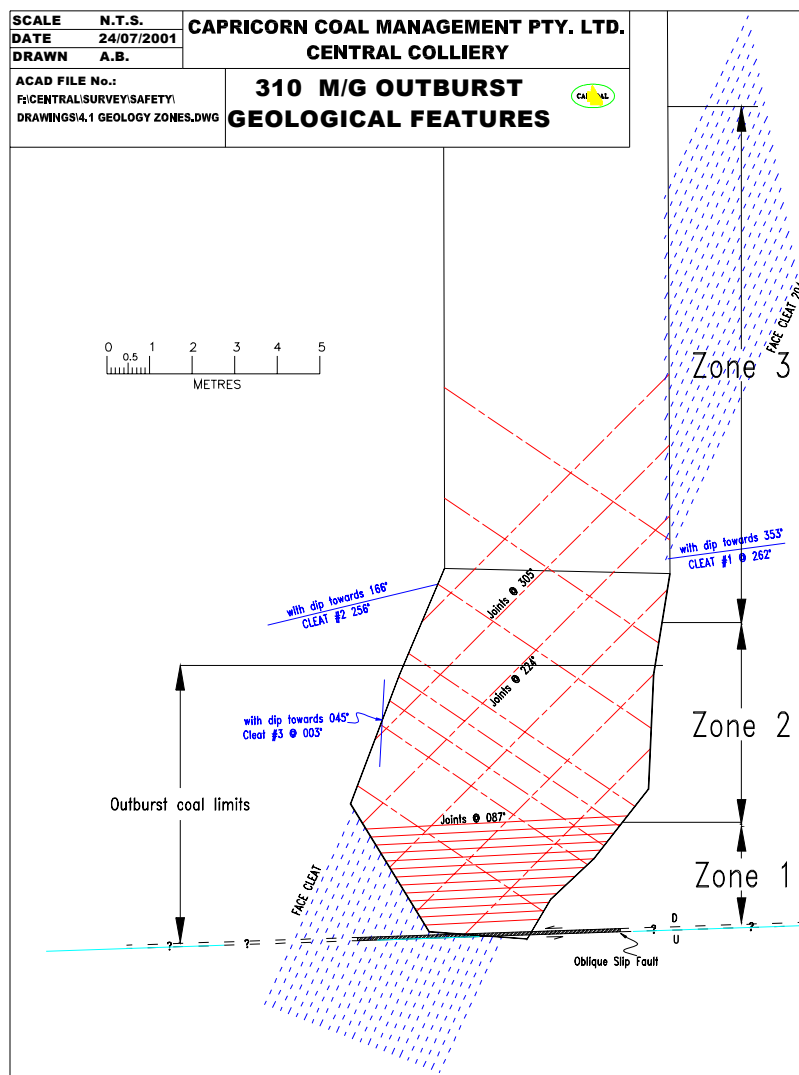
**Fig. 4 310 Panel Outburst Cavity – Geological Features**

Most of the displaced coal was of blocky consistency. A structural change in the local geology had been noticed over the last 30m of the development. The normal cleat is first intersected by the left rib, but additionally, another three cleat orientations were noticed as shown in Fig. 4. Some of these additional cleat orientations have been present at times elsewhere in the mine, but at this location it is remarkable how consistently they occur in their attitude (strike and dip), persistence and spacing. In addition, the roof joint pattern appeared to alter, in terms of spacing from a normal one every three to six metres to approximately one every metre. In the outburst cavity itself these joints appear at a spacing of only 30cm semi-parallel to the identified outburst structure.

The main structure associated with the outburst is interpreted to be a strike slip fault, with a nominal dip slip component. The axis of the outburst was perpendicular to the structure, and it could be said that some nine metres of the seam outbye of this main feature was affected by the geological disturbance. Subsequent to the outburst drilling using Pro Ram holes ahead of the two faces bogged in the approximate locations of where the main structure is located. In one particular instance in one of these boreholes, a gas push, through the drill string was recorded. Subsequent testing of this area indicated a content of 11.68m<sup>3</sup>/tonne of mainly methane gas in the down dip side of 'B' heading.

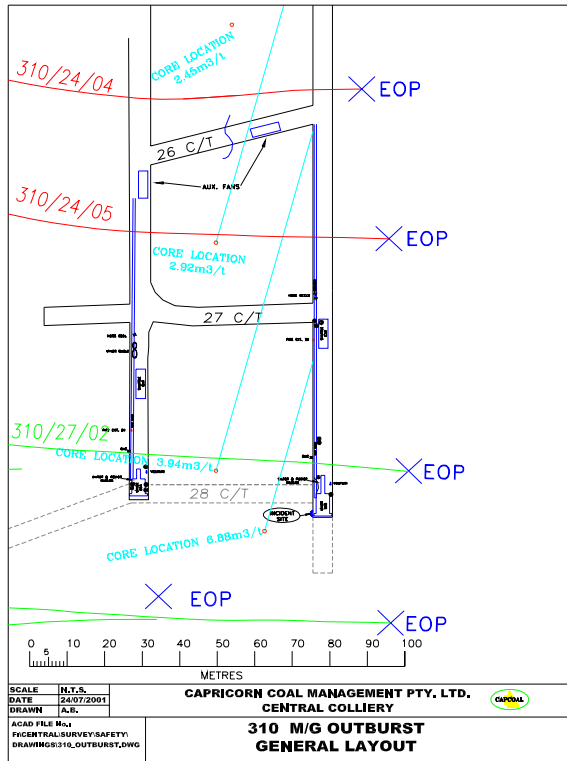
Fig. 5 Inseam Gas Content – Prior to Outburst

Events leading up to the outburst were that the 2-entry panel was to be extended to 28 cut-through, with normal mining proceeding at that particular stage. Inseam drilling was in place to determine the gas content levels. The area had been drained by the standard cross panel drainage holes drilled to a spacing of 40m. Drainage is normally quick and efficient. The 12 to 15m<sup>3</sup>/tonne are usually reduced to 3 to 4m<sup>3</sup>/tonne within 6 to 8 month's time. A core taken from a vertical hole prior to mining, just outby of the outburst site had a gas content of 6.8m<sup>3</sup>/tonne. The next test core, some 140m inbye had a content of 7.8m<sup>3</sup>/tonne. The gas content threshold is 8m<sup>3</sup>/tonne.

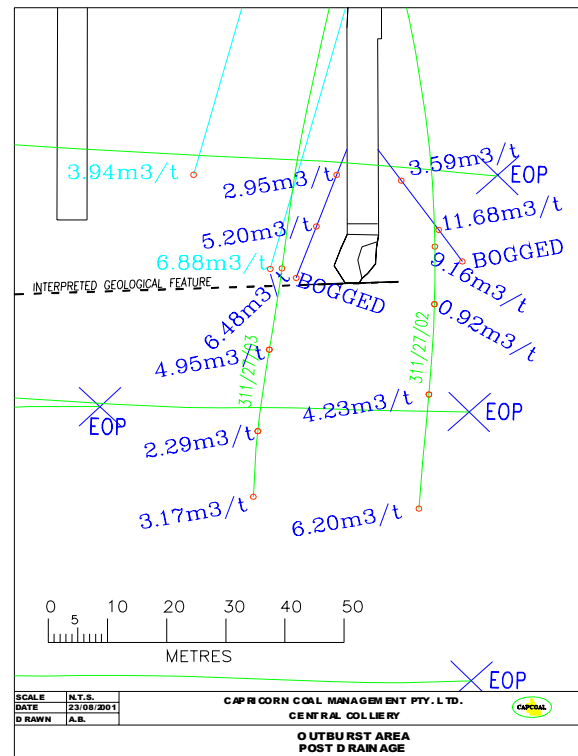
Fig. 6 Inseam Gas Content – After Outburst

Additional holes were drilled between the headings to establish gas contents and the location of any structures. The threshold for the area was temporarily reduced to 6m<sup>3</sup>/t, and if the core content from this area was greater than 5m<sup>3</sup>/t, then additional cores were to be taken at 25metre intervals. Fig. 5 shows the general arrangement of in-seam borehole locations pre – outburst, whereas Fig. 6, is the in-seam borehole and sampling arrangement post – outburst. Positive outcomes from the work were that the “geologically disturbed zone “ was positively identified from three in-seam intersections and seam gas contents dropped markedly away from this disturbance.

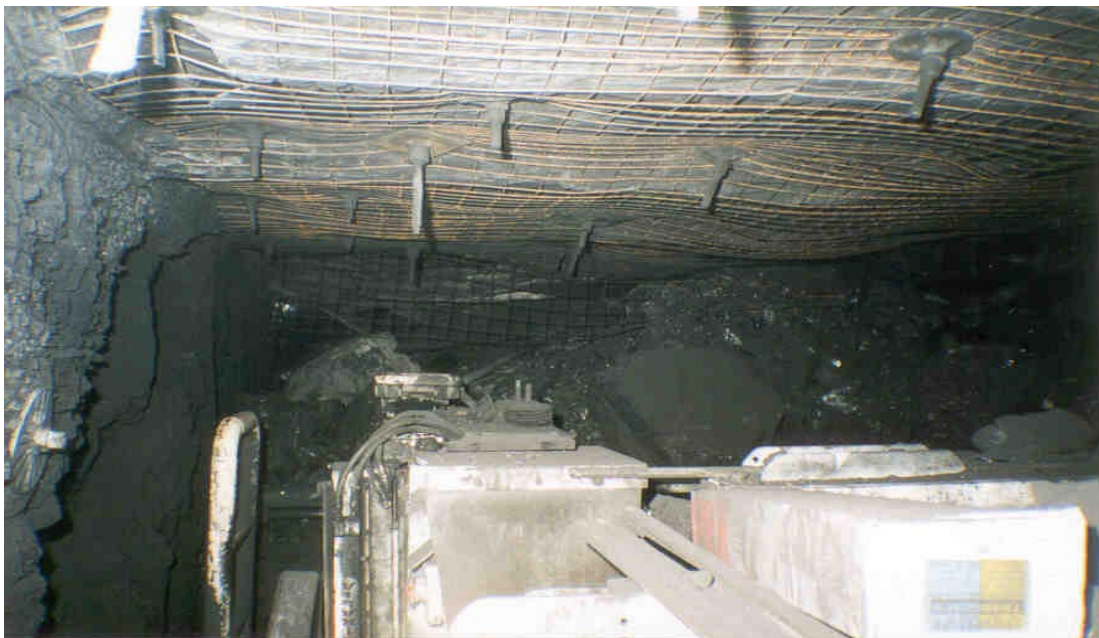
**Photo 1 Outburst Area**

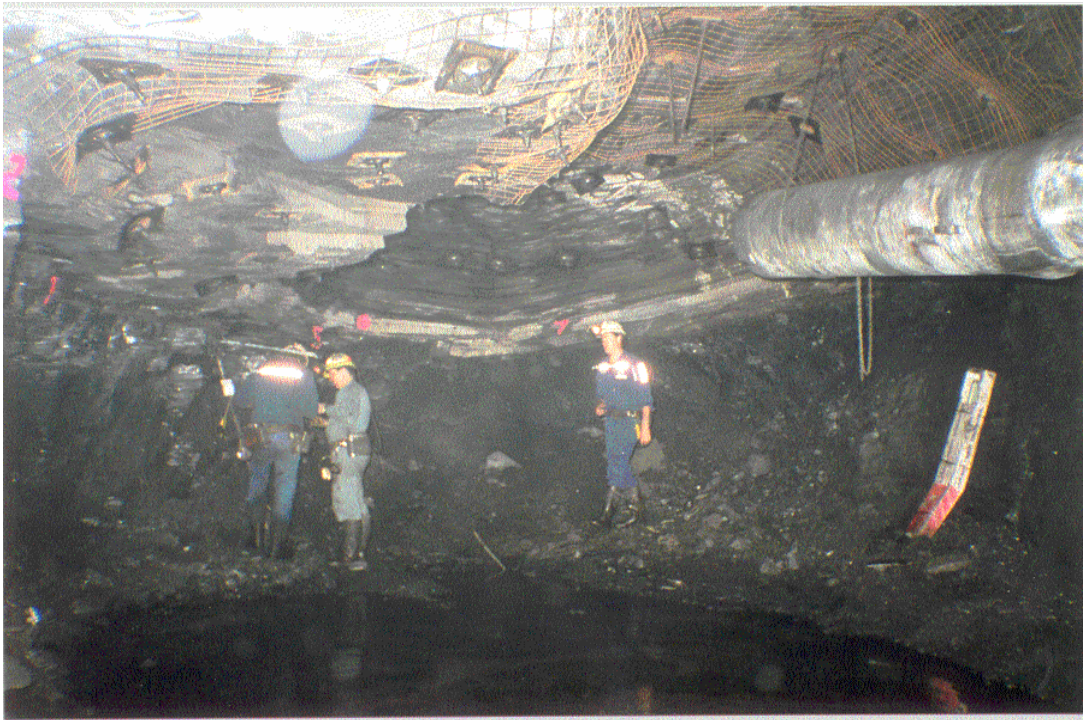
**Photo 2 Outburst cavity after cleanup**
