INVESTIGATIONS AIMED TO IMPROVE TAILGATE SERVICEABILITY AT DARTBROOK MINE

ABSTRACT: Dartbrook Mine has experienced rib control difficulties because of deterioration in the tailgate corner of the longwall face as overburden depth has increased. This paper summarises an investigation to optimise support and develop strategies to improve the serviceability of the tailgate roadways.

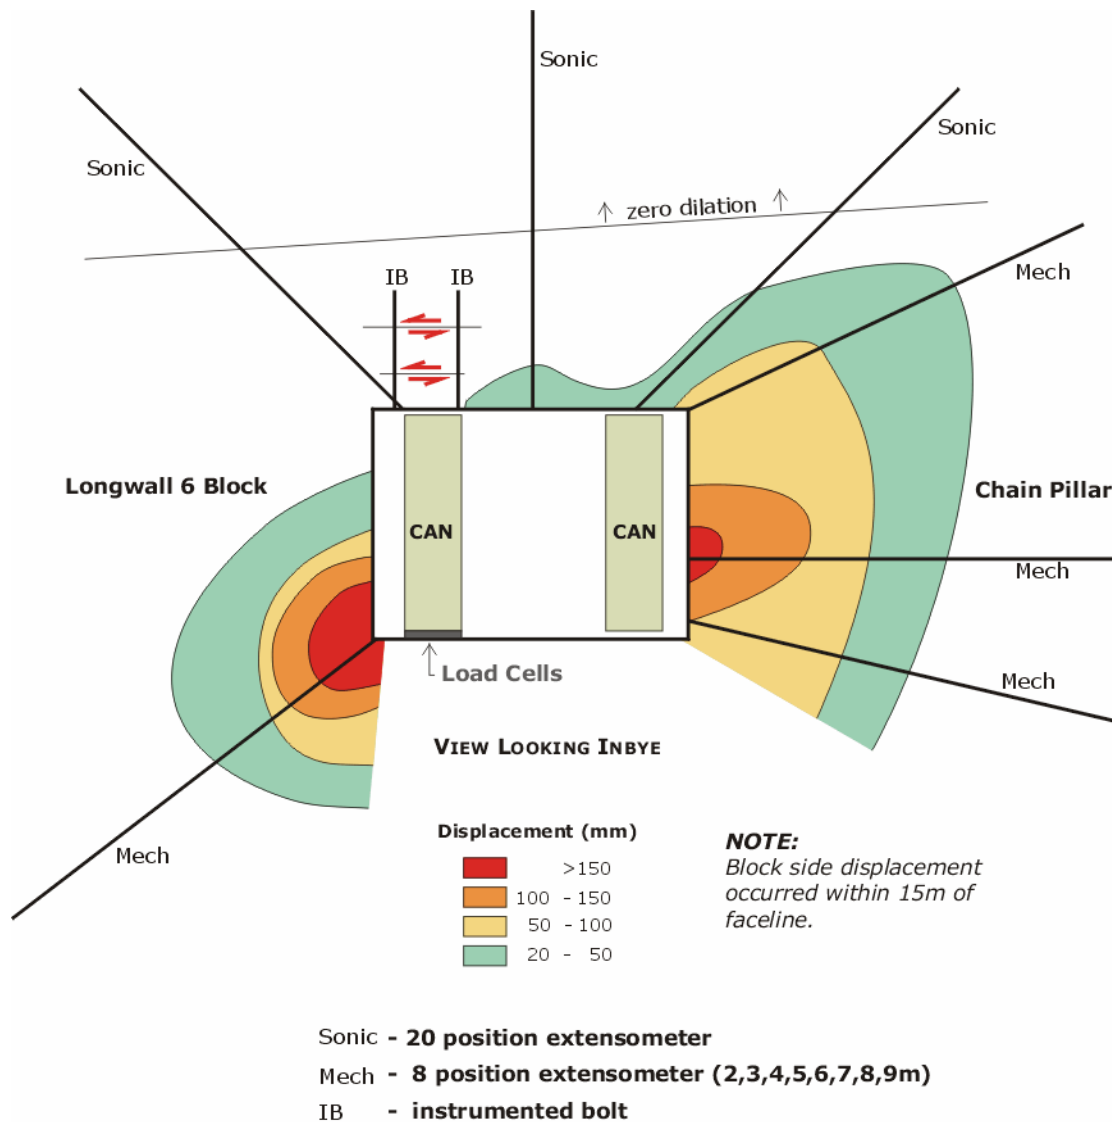
Figure 1 Displacement summary and layout of instrumentation Longwall 6 tailgate, inbye 10 C/T.

The deformation characteristics of the monitoring sites are included in Fig. 1. Results are summarised as follows:

- Softening of the ribs both sides of the roadway (5.4m wide by 4.0m high) occurred to a depth of approximately 5m.
- The softening within the ribs extended into the floor on the block side and the roof on the chain pillar side.
- The intensity of the softening increased steadily from approximately 75m outbye the faceline and accelerated within 20m of the faceline.
- The roof and floor outside the area described above exhibited minimal deformation until within 20m of the faceline. Then the movement within this area was characterised by shear displacement along horizontal planes, essentially creating a shortening of the roof and floor heave.

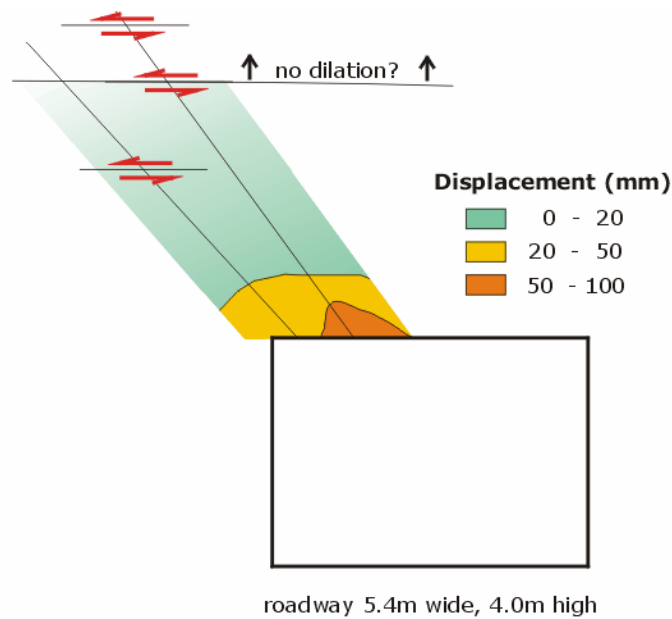
Results from the 5 Cut-through monitoring site are summarised in Figure 2. The location of and sense of shear displacement is apparent. A contour of displacement measured by the extensometers is also shown.

Figure 2 Displacement summary - Longwall 6 tailgate, inbye 5 C/T.

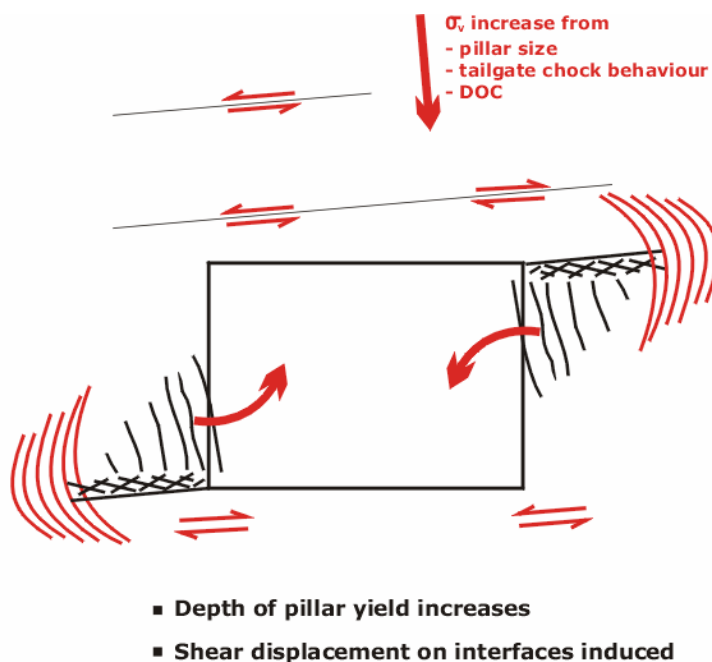
Deformation is characterised by intense shearing of the rib in the top right and lower left corners of the ribs looking inbye as shown in Fig. 3. The zone of intense shearing extends sub-horizontally into the rib for an estimated distance of up to 2m. Further rib spall associated with cleat produces a softened zone extending into the rib some 50% to 65% of the rib height. The lower right and upper left ribs looking inbye typically exhibit no visible signs of deterioration.

Figure 3(a) State of softening during longwall advance Longwall 6 tailgate (<75m from face).

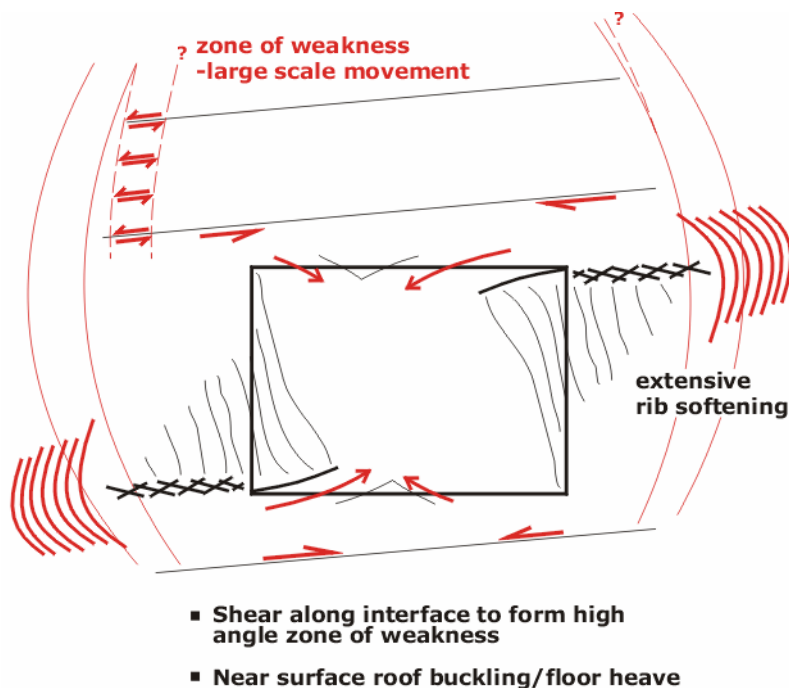
Figure 3(b) Late stage deformation (<20m from face).
