A Review of Fatal Outburst Incidents in the Bulli Seam

C R Harvey¹, R N Singh²

ABSTRACT

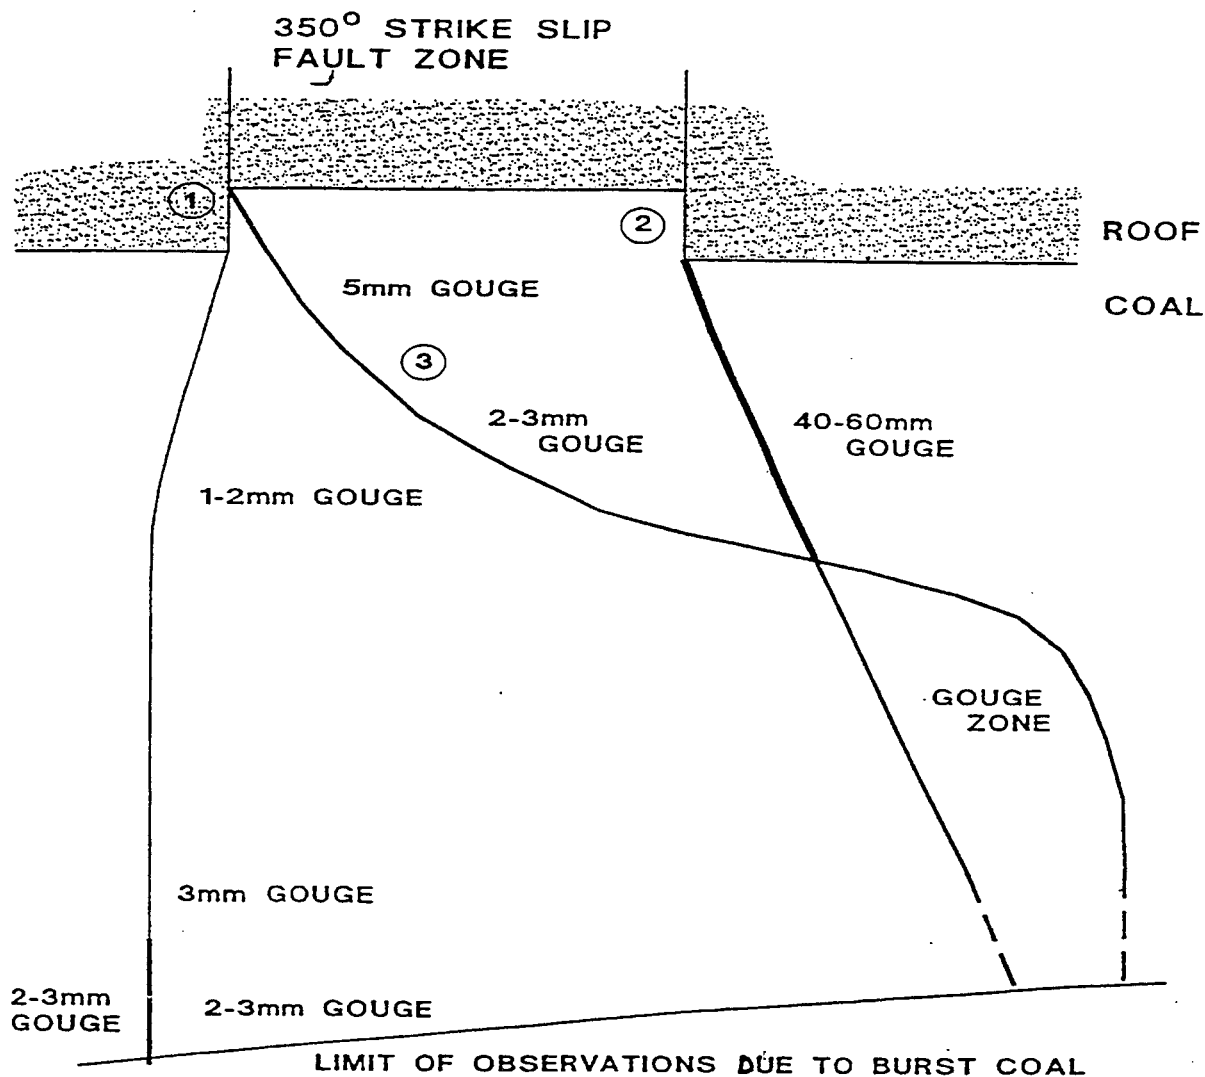
As shown in Figs 3, 4 and 5, the outburst was associated with a combination of two strike slip fault zones (one trending 350°, the other 280° magnetic). The intersection of these two fault structures created a zone of intense shearing/jointing resulting in lower coal permeability and increased stress in the coal and associated roof strata. This in combination with the presence of Mylonite and gouge material was believed to account for the volume of gas released.

- 1 88° to 264° MAGNETIC STRIKE SLIP
- 2 STRIKE SLIP
- 3 DIP SLIP

Fig. 5 - West Cliff Colliery 286 right panel outburst and fatal accident section through strike slip fault "b" heading southern rib
