## LONGWALL MINING THROUGH FAULTS AT MORANBAH NORTH

Chris Hanson<sup>1</sup>, Brett Moulle<sup>2</sup>, Chris Strawson<sup>3</sup>, and Andrew Laws<sup>4</sup>

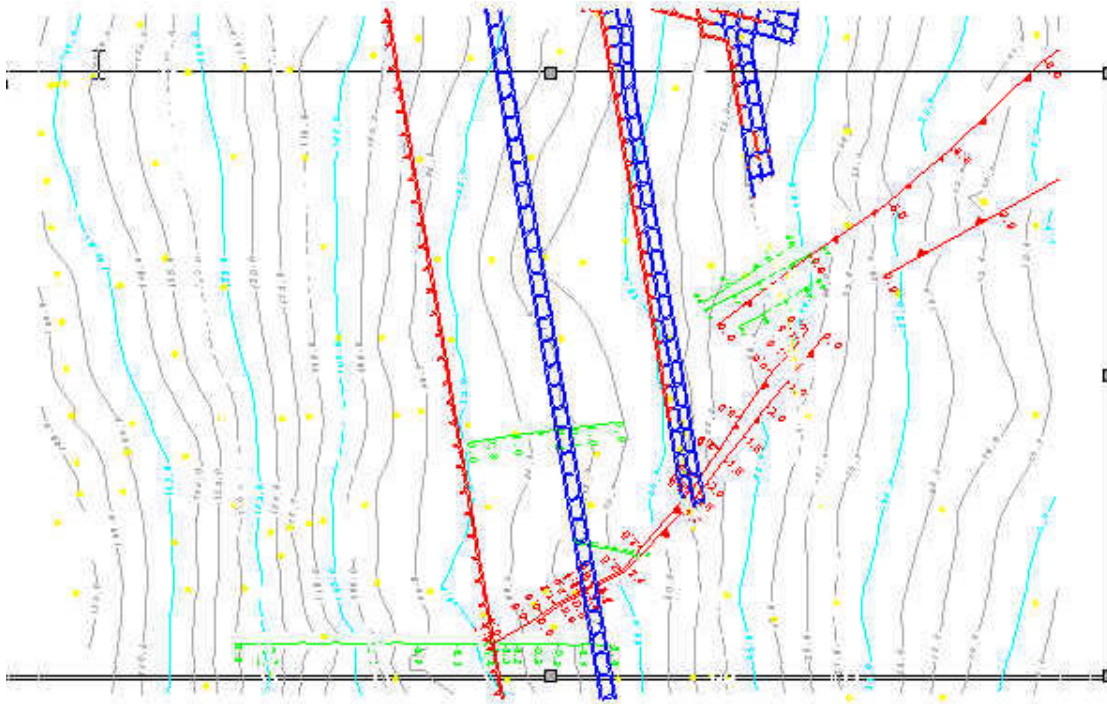
**Fig 5 – Maingate 103 fault interpretation following seismic, in seam and surface drilling**

Figure 5 shows a structural interpretation following the use of more sophisticated exploration techniques including seismics, in seam and surface drilling to produce a more detailed and confident geological structural interpretation. Figure 6 shows the detailed mapping following development while Figure 7 an interpretation of the gradient changes.

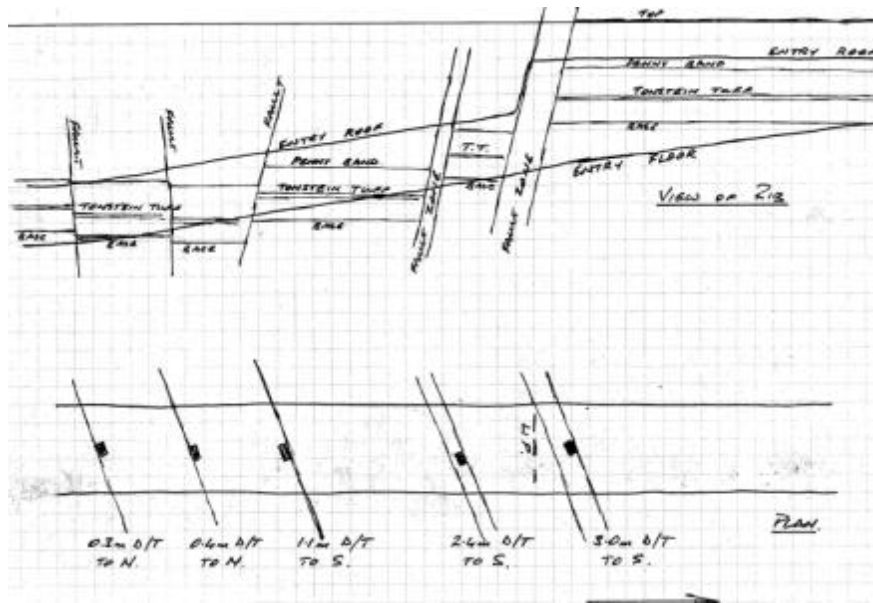
Fig 6 – Maingate 103 mapping of maingate fault system

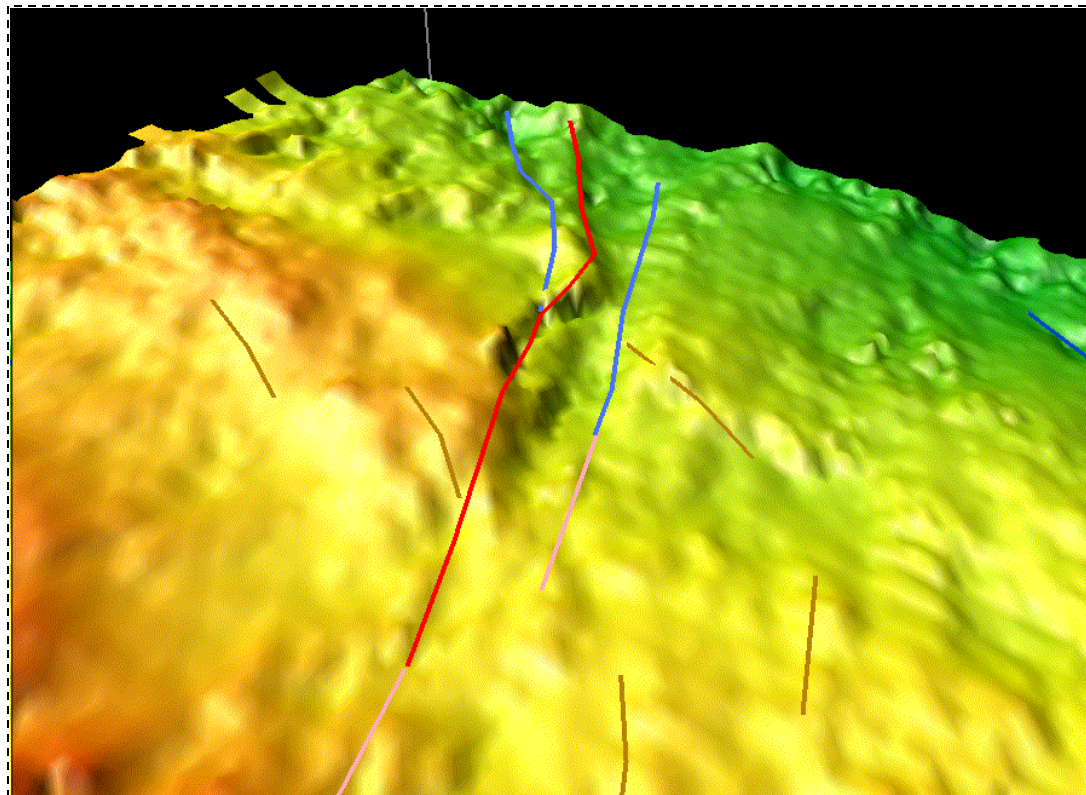
Fig 7 – Seismic (dip gradient change) interpretation of LW103 fault zone

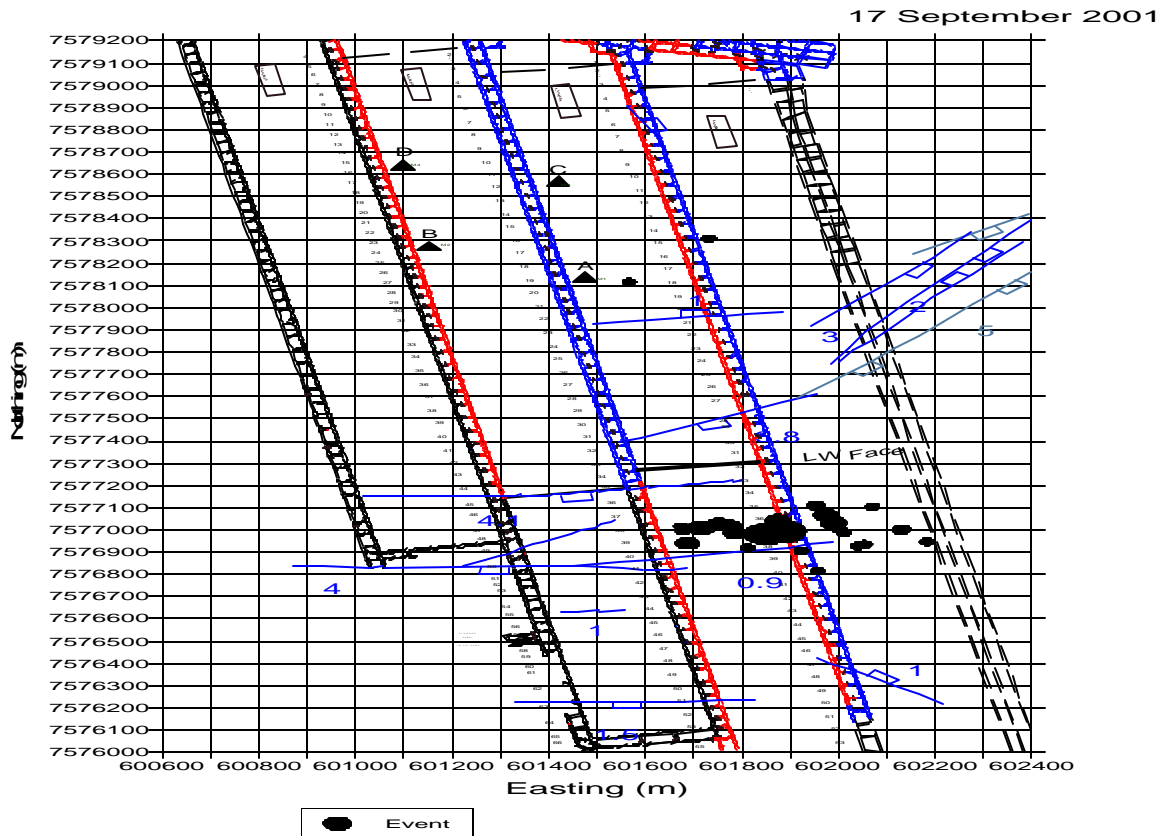
The microseismic monitoring indicated few events located around the fault zone itself, which is likely considering the inability of faults to transmit shear forces across the fault plane. Most significant microseismic events were located 100m – 300m inbye of the longwall face, biased towards the maingate end. Figure 8 shows a typical microseismic plot with the size of event indicated by the size of the circle.

**Fig 10 – Typical microseismic monitoring plot as longwall face approached fault zone  
Note lack of activity**

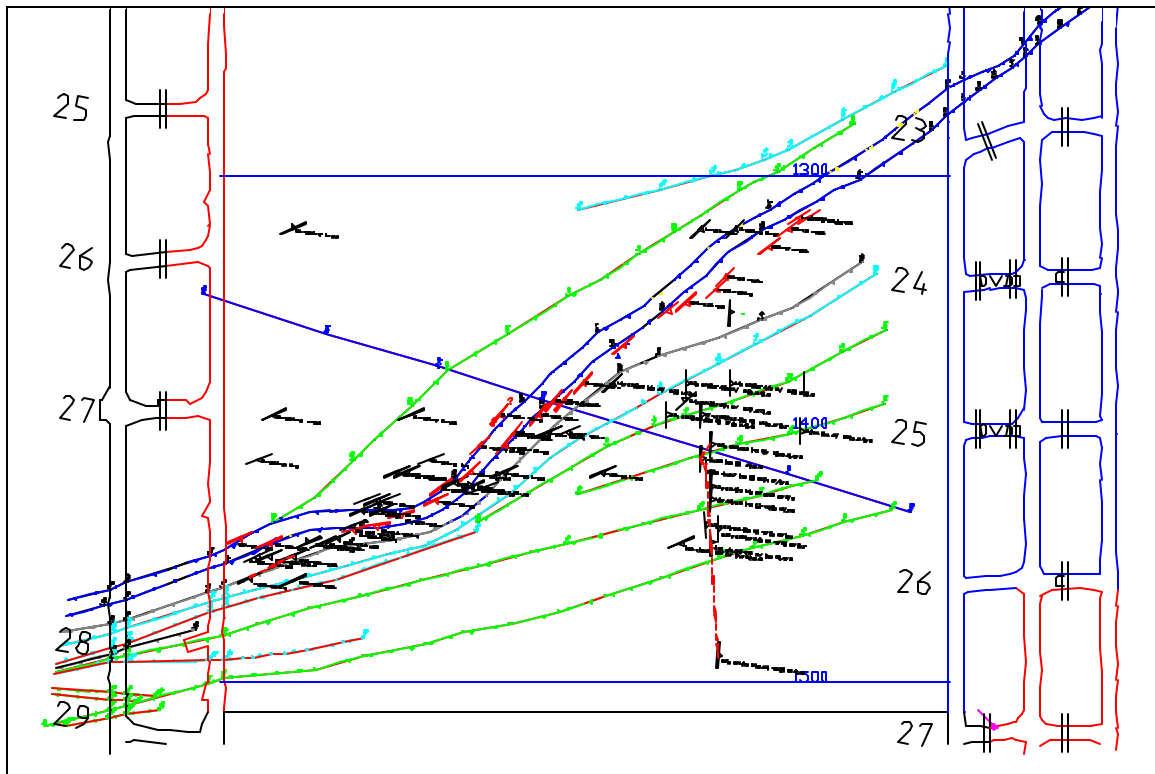
The actual vs predicted fault locations proved to be reasonably accurate as illustrated in Figure 12.

Fig 12 – Actual vs predicted fault structures –LW104 fault zone

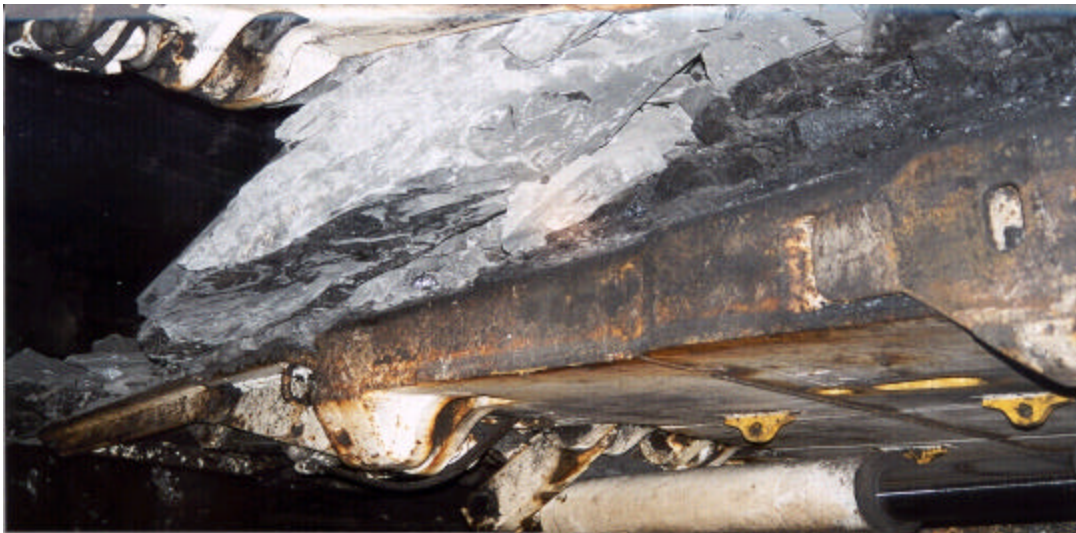
During mining of the last 8m of the fault zone in the maingate, a failure of the rib along the jointing, (running sub parallel to the gate road), allowed a large fall to occur in the maingate, and on the face, see Figure 13. A significant quantity of material had to be removed from this area, and blasting of the stone in the fall was required.

**Fig 13 – Open cavity above the gate end supports at the maingate LW102**

The grouted false roof, installed to allow the maingate chocks to push forward, came loose, and added to the fall. In addition, the cut height on the face, was 750mm lower than planned, mainly due to soft floor. This exposed more block side rib, possibly assisting in the rib failure. 18 days were lost due to this failure.

- Stability of the maingate block side rib is crucial where the faulting intersects the gateroads.
- The provision of an accurate fault 'Flight Plan' is vital to success in mining faults. It is important that all the longwall equipment parameters are fully known and understood. (i.e. in some cases manufacturers figures bear re checking)

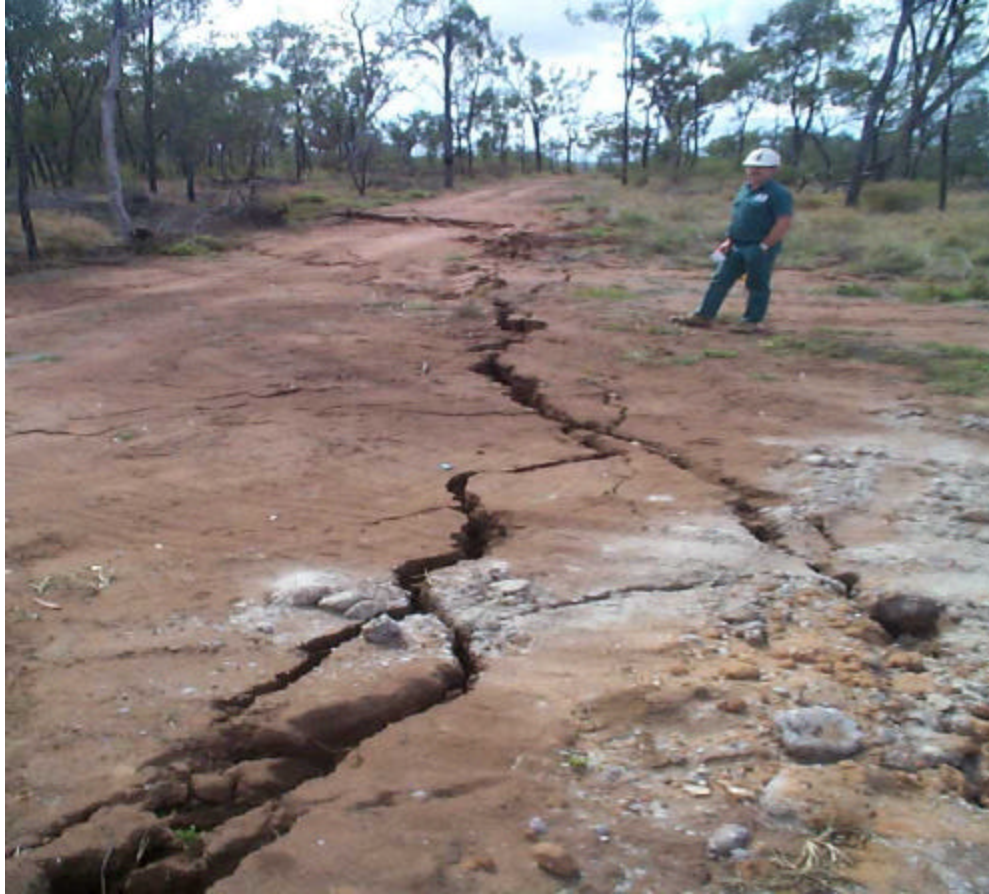
The increased relative level of subsidence recorded inbye of the fault position at the tailgate end is clearly visible. It should be noted that this area is in close proximity to the roof fall in LW102 MG, where a substantial quantity of material was removed.

Fig 19 – Surface subsidence over fault zone – LW103

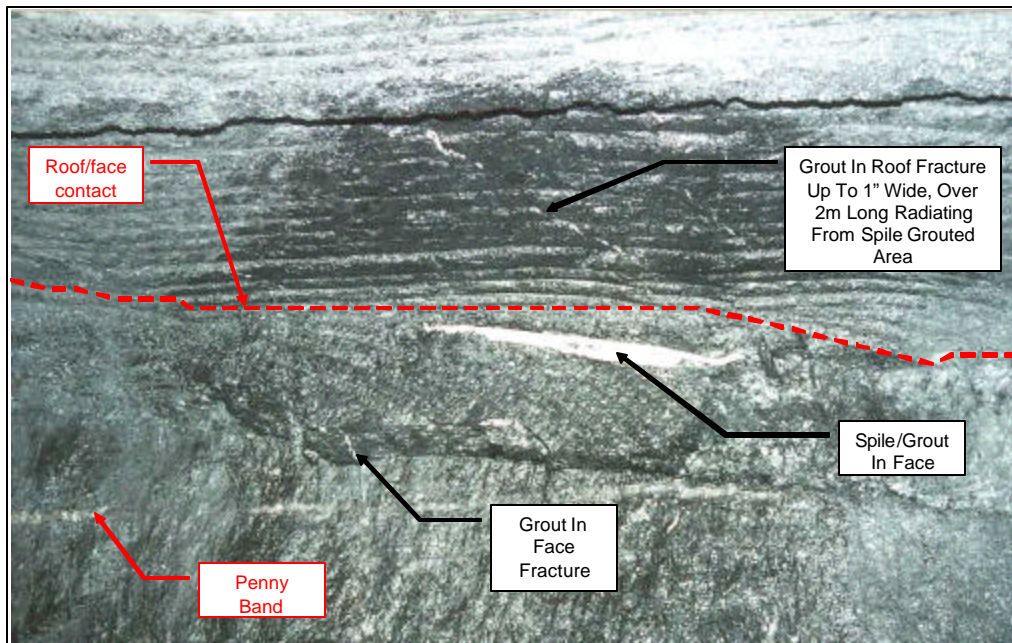
Fig 20 – Grout permeation in face due to pressurized grout injection – LW103
