## STRATA MANAGEMENT AT THE GOONYELLA EXPLORATION ADIT PROJECT

*ABSTRACT:* The Goonyella Exploration Adit is a three heading development into the highwall at Ramp 4 at Goonyella Riverside Mine that was driven between September 1999 and November 2000. The principal was BHP Billiton Mitsubishi Alliance (BMA) and the contractor was Allied Mining Australia. Strata management began at the pre-tender phase and evolved as greater knowledge of the ground became available.

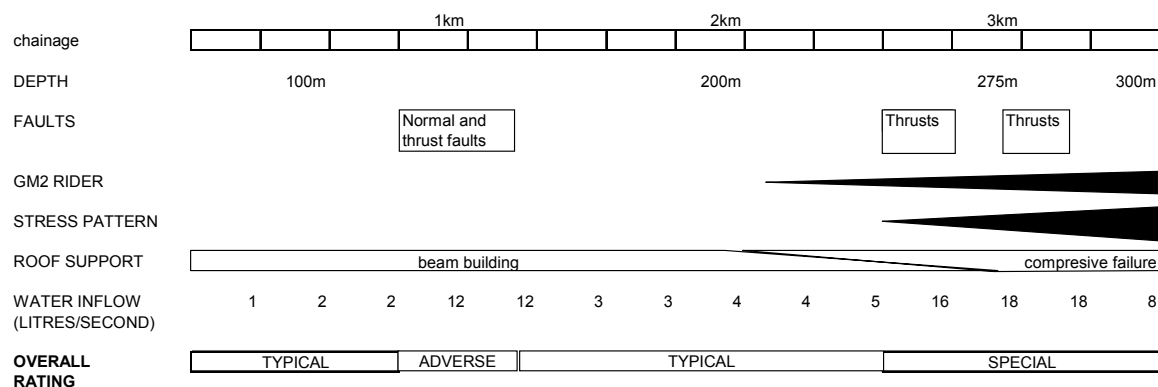
Fig. 1 Zonation of the adit at tender stage

As one of three geotechnical consultants, Seedsman Geotechnics Pty Ltd (SGPL) prepared a report that identified three ground types (Figure 1) based on an approach used in civil engineering. These are as follows:

Special conditions were identified beyond chainage 2500m as a result of a combination of thrust zones, higher ground stresses related to the greater depth of cover, proximity of rider seams, higher water inflows and other factors. It was recognised that there could be undetected faults at any depth that would be classified as special ground.

The project team knew of the experiences with faults at North Goonyella, and were fully focused on the possible impact of the known and unknown faults at Goonyella. The 3-D seismics had identified a number of large thrust faults well inbye of the portal (Figure 1) and the strategy was to mine up to them and develop support strategies after some experience had been gained with the seam. The large thrust faults were traversed without problems, because of the lessons learnt from a fall on a minor thrust fault outbye.

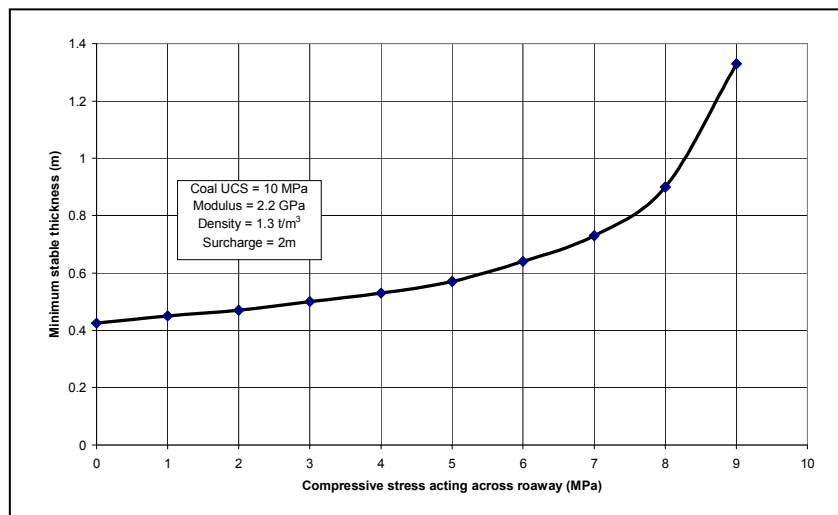
Fig 2 Analysis of a coal beam

The top ply is highly banded and experience shows that it is not self-supporting. Ply 2 is a massive coal band and calculations suggested that so long as 0.4m to 0.5m was left uncut it could span across a 5.5m roadway (Figure 2). If such a unit could be formed then an extended cut could be taken and hence allow cut and flit mining. The 1.5m roof coal criterion at Moranbah North was interpreted to be the composite of the 1m Ply 1 acting as a surcharge on a 0.5m structural beam of massive Ply 2 coal.

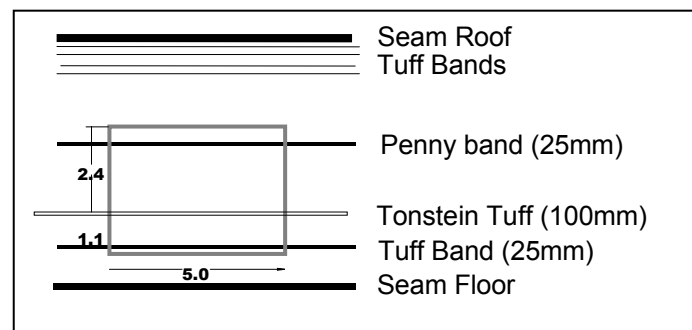
**Fig. 4 Horizon control for typical ground**

Typical ground was defined as that part of the driveage having a massive immediate coal roof. To achieve this, horizon control was essential and it was instilled into the work force. They all carried the simple diagram shown in Fig. 4 which was an idea copied from Moranbah North. Since Ply 2 is about 2m thick and only 0.5m had to be left, normal faults with throws of up to 1.0m to 1.5m could be traversed (so long as the fault plane itself was supported).

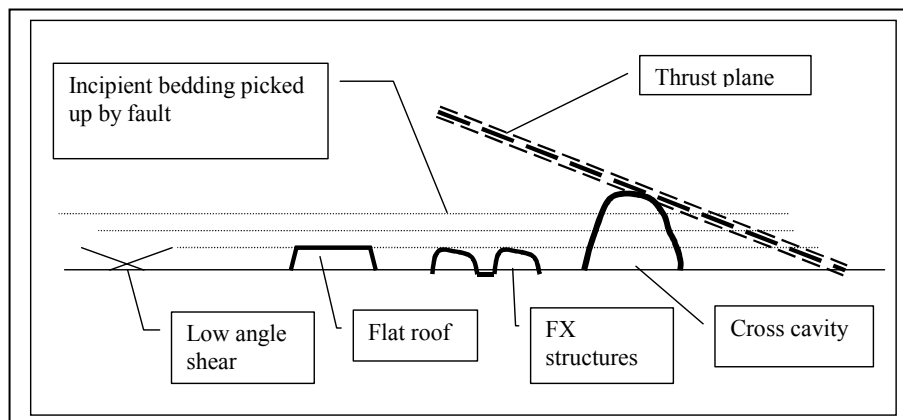
**Fig. 5 Roof conditions on the footwall of thrust faults**

Back analyses of the roof conditions as the thrust faults were approached from the footwall (downthrown) side allowed the formulation of a predictive model for the proximity to such faults (Fig. 5). The shallow, flat-topped roof falls began about 20m - 30m prior to the thrust plane being intersected. This model successfully identified all subsequent thrust faults and complemented the surface exploration: 3 D seismic survey were invaluable as a planning tool and was found to be accurate for faults greater than 3m, but less than 50% for smaller throws for which the observational model was essential.

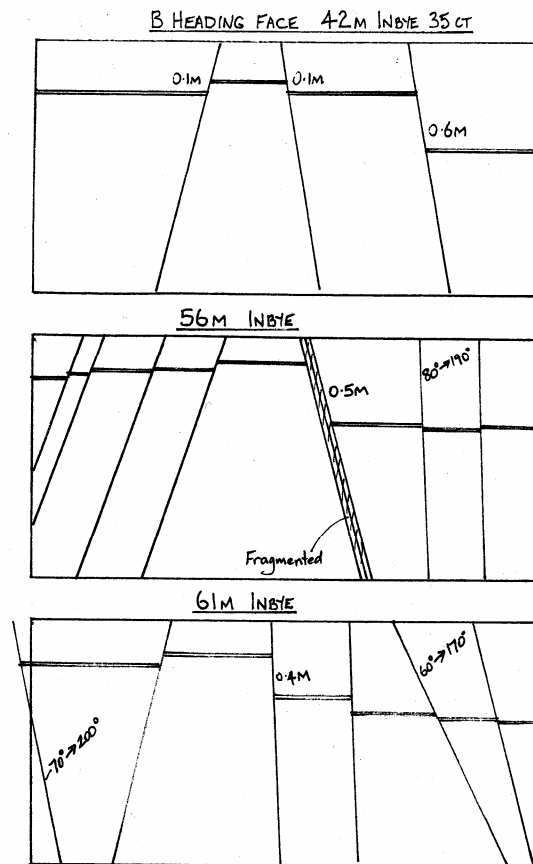
Fig. 6 Face mapping of horst/grabens

At around 21 c/t in A heading, and particularly in C heading inbye of 29 c/t, the driveage encountered what became referred to as 'trench roof'. This coincided with the presence of small-scale normal faults in a horst/graben configuration (Fig 6). The headings were sub-parallel to the strike of the horst/grabens.

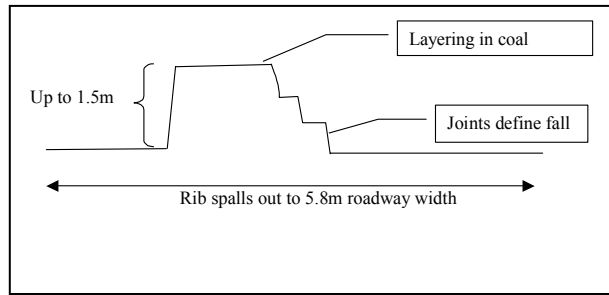
Fig. 7 Cartoon of the roof falls

Roof falls developed soon after the start of each plunge (Fig. 7). The falls involved the collapse of joint/fault-bounded blocks of coal from the roof. These blocks were often in the order of 300 mm to 500 mm wide and resulted in the formation of a trench in the roof. There was no rock noise associated with the falls. The longer the plunge, the higher were the roof falls – the maximum fall height recorded was about 1.5m and this happened when the plunge was extended to 5m. Trench roof was only recorded in the headings, not in the cutthroughs. The falls occur as joint-bound trenches over about half of the roadway. The fall zone migrated from the north rib to the south rib of each roadway and in this way migrated from A heading to C heading.

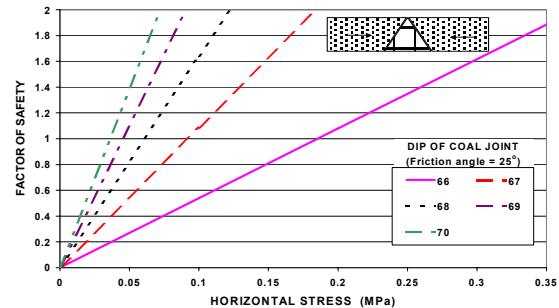
Fig. 8 Wedge analysis for coal roof with low horizontal stresses

The falls were interpreted as being the result of low horizontal stresses acting on wedges of coal defined by the horst grabens. The low horizontal stresses resulted from the interplay of the roadway shape with a low magnitude stress field where the major principal stress is vertical. Simple wedge analysis indicated that falls were likely for discontinuities dipping at between 70° and 65°, and inevitable for surfaces dipping at less than 65° (Figure 8). The height of the falls was controlled by the onset of a more compressive regime higher in the roof.

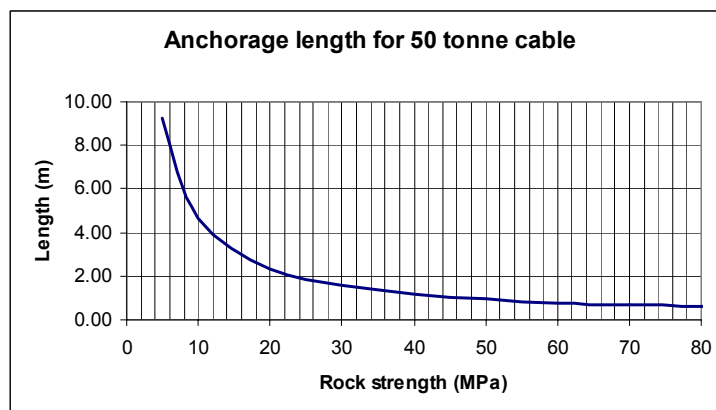
Fig. 9 Required anchorage length for cables

Monitoring identified some areas where the post-installation movement of cables exceeded the 10mm threshold. A review of the ground conditions identified that these areas were associated with low strength strata in the anchorage horizon. The distribution of overall stone roof strengths was known from sonic logs. A nomogram was developed relating anchorage length to rock strength using standard ground engineering concepts (Fig. 9). From this nomogram came the requirement for 10m long vertical cables to achieve adequate anchorage in some areas. In other areas, higher strength sandstones within the fall horizon could be exploited if angled cables were installed over the pillars.

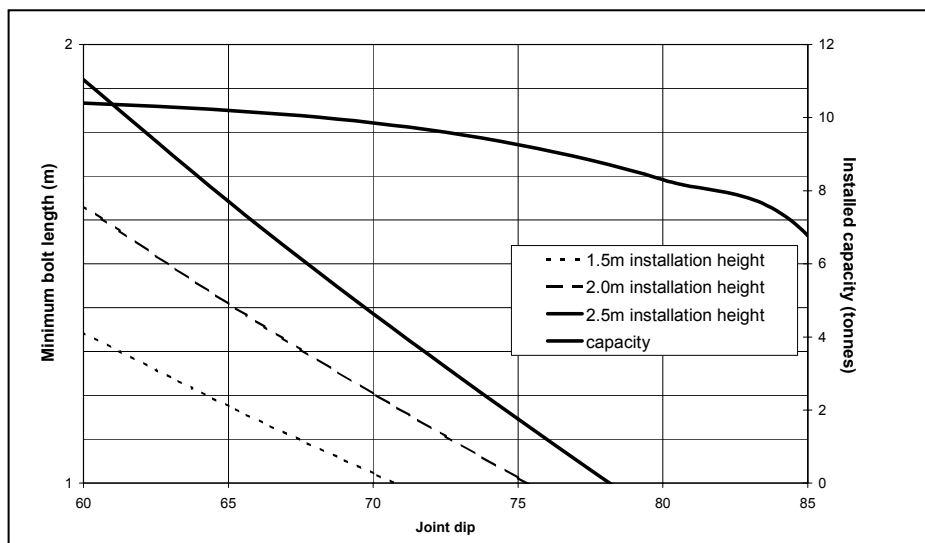
Fig. 10 Rib bolt requirements

The high ribs required support in areas where the spacing of coal joints was less than about 300mm, and also in the horst/graben areas. The support design was based on the assumption of joint defined planar slides. The dip of the joint is an important control on the weight and dimensions of the failure block (Fig. 10). Ten tonne capacity rib bolts gave a factor of safety of two against the design blocks. Depending on the height of installation, bolt lengths of 1.2 to 1.5m were required to ensure anchorage beyond the joint plane.
