Stress Corrosion Cracking of Rock Bolts

P Gray¹

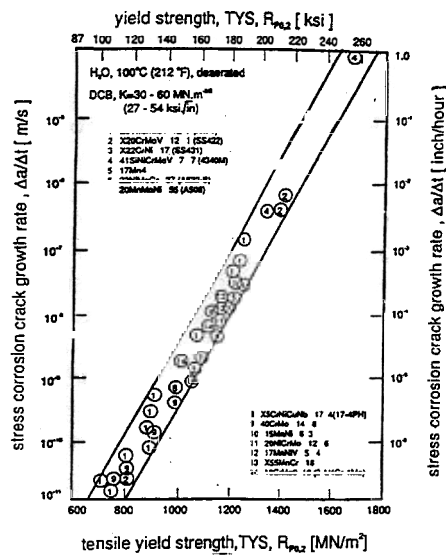
Fig. 1 - SCC growth rate vs tensile strength for high strength steels (after Atrens & Wang, Ref.1)

Figure 1 indicates that SCC can occur in a wide range of steel types (after Atrens, Ref.1). However, Figure 1 also shows that higher strength steels are generally more susceptible to SCC than lower strength steels. It can be seen that the crack growth rate is approximately 10^{-6} m/sec for steels with an ultimate tensile strength (UTS) of 1400 MPa, compared to a crack growth rate of only 10^{-11} m/sec for steels with a UTS of 600 MPa (Ref 1).
