## LONGWALL MINING THROUGH FAULTS AT MORANBAH NORTH

Chris Hanson<sup>1</sup>, Brett Moulle<sup>2</sup>, Chris Strawson<sup>3</sup>, and Andrew Laws<sup>4</sup>

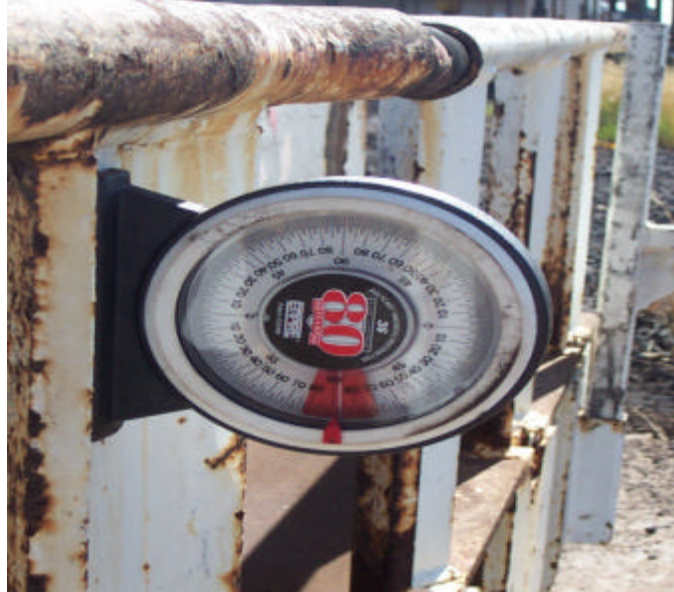
**Fig 17 – Magnetic Inclinometer attached to Bretby. Panline LW103**

- The tailgate received additional support in the form of fully grouted, and trussed cables across each fault, and closely spaced Link and Lock standing supports. A 1.4 x 1.4m Link and Lock was especially produced for installation in the higher areas.
- Inclinometers as shown in Figure 17 were used on the face (Pan line), allowing the crews to have a simple form of assessment of the attitude of the longwall equipment.

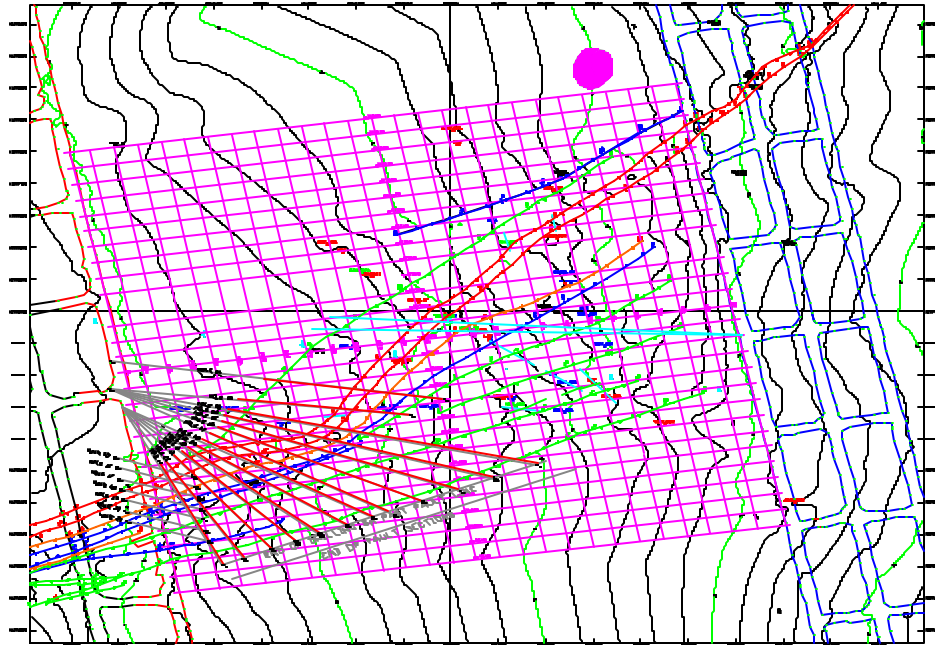
Fig 21 – Tailgate 'Spile' plan. LW103

A total 15 holes were drilled from the tailgate, and 38 from the maingate. Again, the holes were 56mm diameter, and 38mm thick walled tube was installed, and grouted. In this instance, the grout usage was monitored, however no permeability testing was possible due to time constraints. In an area identified as being 'soft' when drilled, it was possible to pump more than 500litres (more than hole capacity) of a Thixotropic grout into each of 5 holes. This would indicate voids in the fault zone were filled. The layout of spiled holes in the tailgate is shown in Figure 21 and in the maingate in Figure 22.

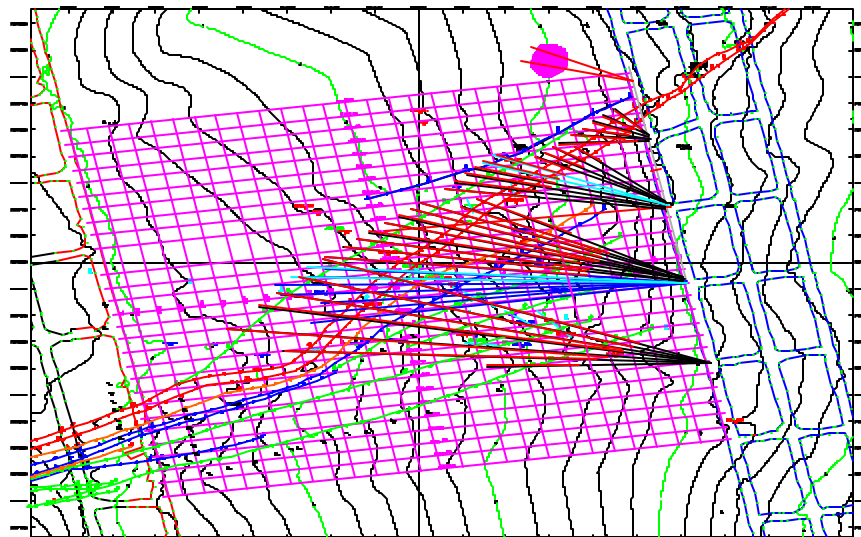
Fig 22 – Maingate 'Spile' drilling layout. LW103
